UCRL-AR-126020-11

LLNL Ground Water Project 2011 Annual Report

Environmental Restoration Department

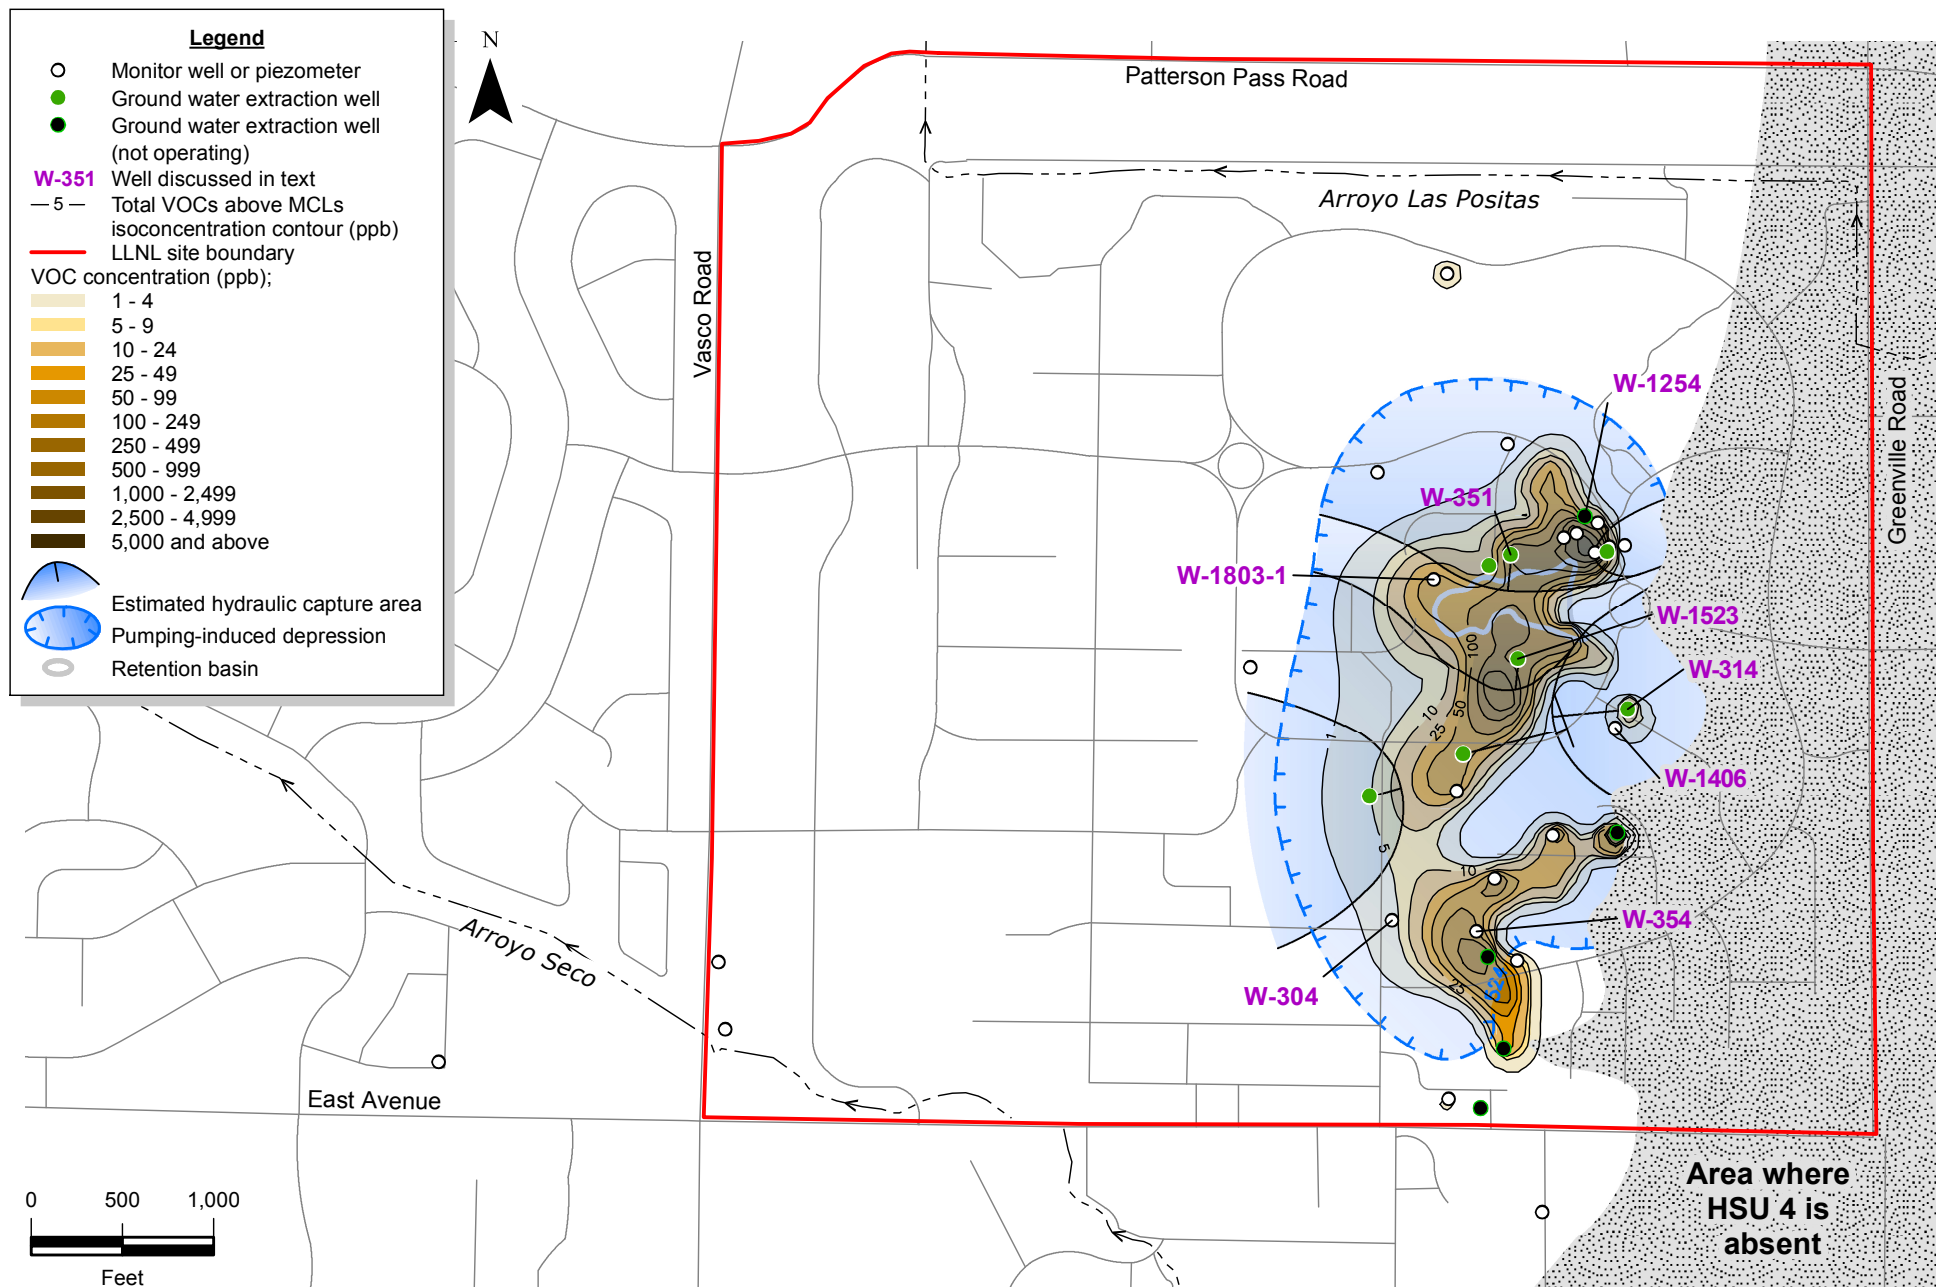
Figure 18. Isoconcentration contour map of total VOCs above MCLs from 42 wells completed within HSU 4, third quarter 2011 (or the next most recent data), and supplemented with soil chemistry data from 57 borehole locations.

Although the position and size of the HSU-4 VOC plumes (Figure 18) were essentially unchanged from 2010, several notable concentration trends were observed during 2011. In the TFD Southeast area, TCE concentrations at extraction well W-314 declined from 190 ppb (October 2010) to 35 ppb (October 2011) in response to pumping at well W-314. TCE at monitor well W-1406 also declined, falling from 21 ppb (November 2010) to 5 ppb (November 2011).
